# Arnold Mill Rd (SR 140) Over Little River

Bridge ID 057-0029-0

**Road:** Arnold Mill Rd (SR 140)  
**Over:** Little River  
**Between:** Old Arnold Mill Rd  
 And Hickory Flat Hwy  
**Structure Type:** Simply Supported Steel Girder  
**Year Built:** 1952  
**Length:** 284 FT  
**Width:** 32.1 FT  
**Span:** 5 Spans  
**Deck:** Cast-in-place Concrete w/Asphalt W.S.  
**Superstructure:** 5 - Steel Girders  
**Substructure:** Concrete Cap and Column  
**Vehicle Protection:** Concrete Railing  
**Paint System:** Lead Chromate Oil Alkyd System  
**Posted Load Limits:** NO  
**Bus Route:** NO  
**Sufficiency Rating:** 39.45  
**Utilities:** Gas  
**Date of Inspection:** 6/2/2008

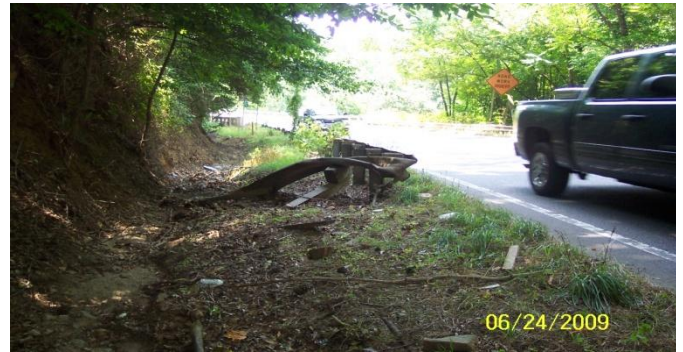
057-0029-0 – Guardrail damage Southwest Corner

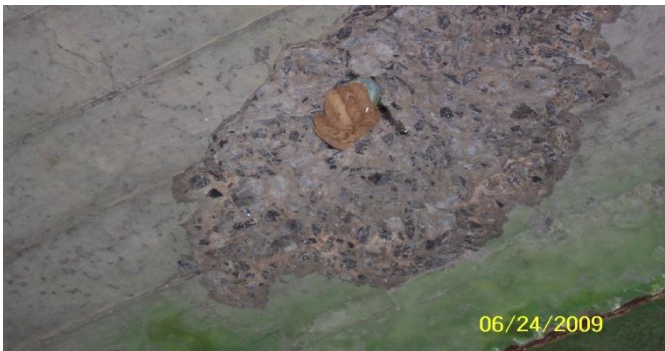
057-0029-0 – Spalling on deck from below

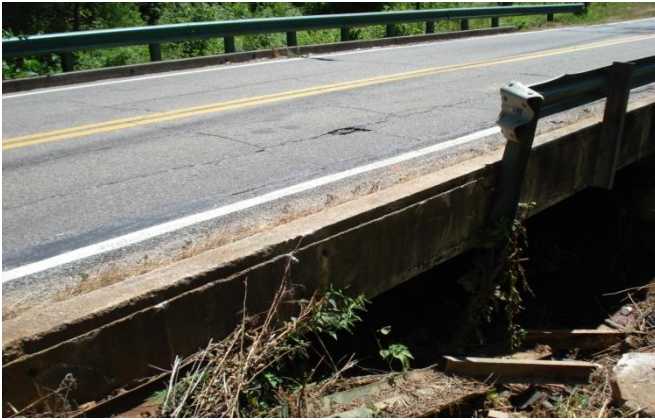
121-0284-0 – Damaged guardrail

**Repair Recommendations:**  
 The steel piles throughout the structure should be cleaned and painted. The asphalt W.S. should be patched and sealed throughout. The spalled concrete/exposed reinforcing on beam panels should be cleaned and patched throughout. Vegetation growing in the vicinity of the structure should be cut and removed. Replace missing guardrail and weight limit posting sign at east end of bridge.

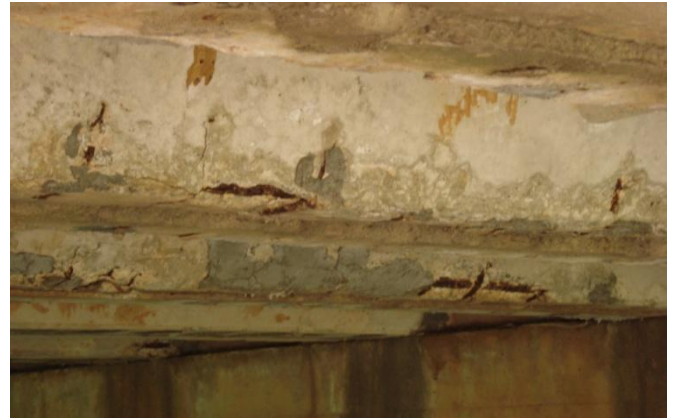
121-0284-0 – Significant spalling

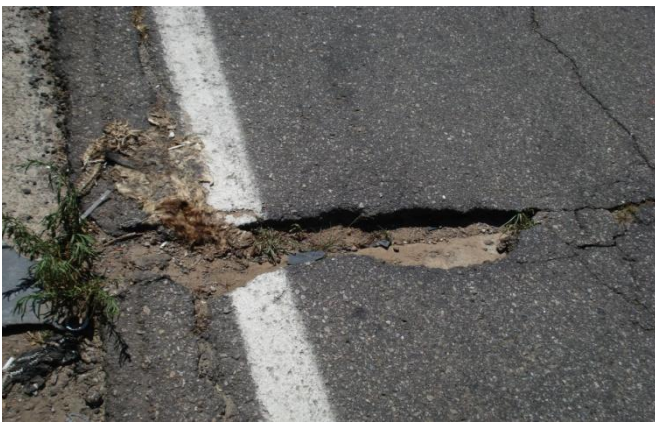
121-0284-0 – Asphalt damage

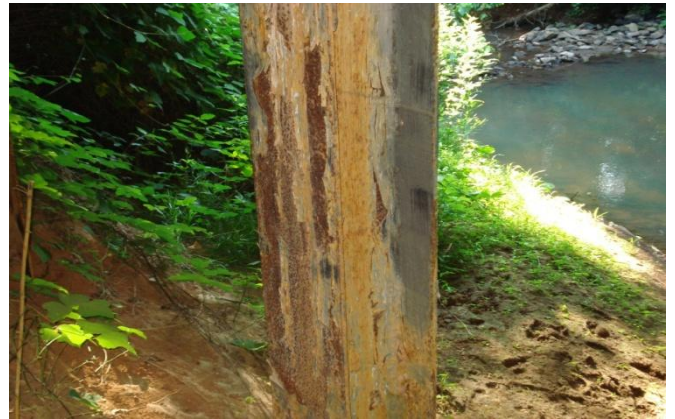
121-0698-0 – Epoxy Mastic peeling off

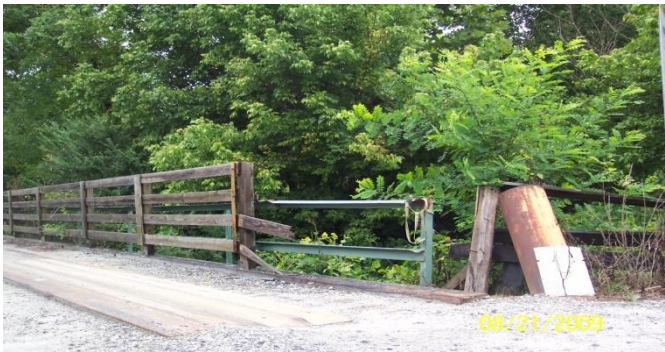
121-5002-0 – Damaged Fence South East Corner

**Repair Recommendations:**  
 The posting sign on the northern end of the structure is missing. This sign is required and must be replaced. Repair or replace metal rail and timber railing system with W-beam guardrail. Install advance signage warning of single lane bridge ahead and load limited bridge ahead. Future recommendation is to replace bridge and realign south approach to eliminate 90 degree bend.

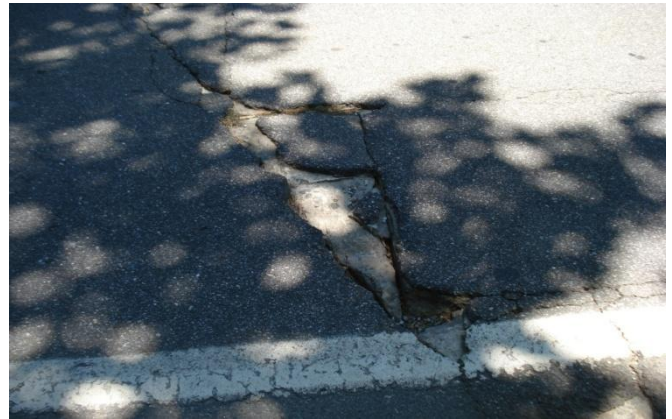
121-5003-0 – Crack between panel and asphalt

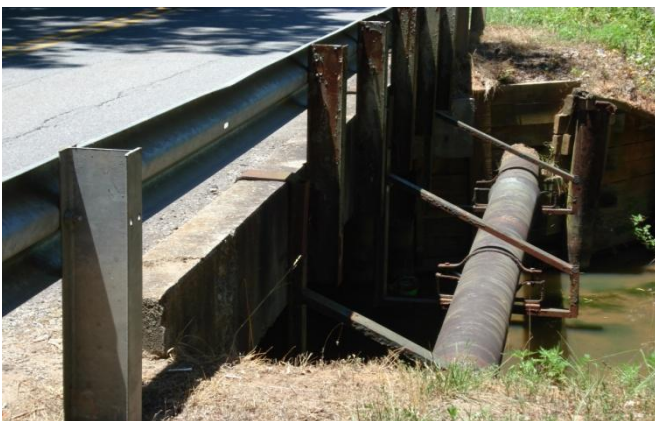
121-5003-0 – Post missing on NE corner

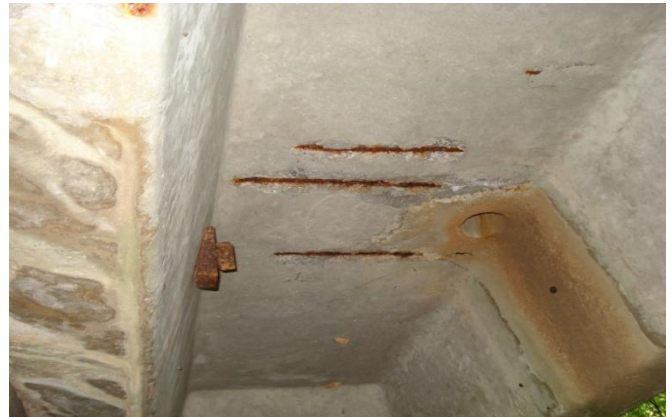
121-5004-0 – Minor spalling with previous patching

Repair Recommendations: Clean and cover exposed reinforcing steel on underside.	Repair/Replacement Priority: Low Estimated Cost for Repairs: \$2,500
--	---

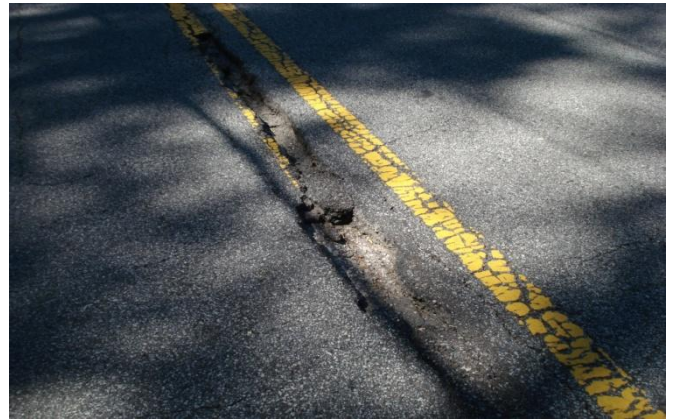
121-5009-0 – Asphalt Damage

Repair Recommendations:  
 Asphalt wearing surface needs to be patched and sealed. Spalling of precast beams needs to be patched, exposed reinforcement needs to be cleaned prior to patching concrete.

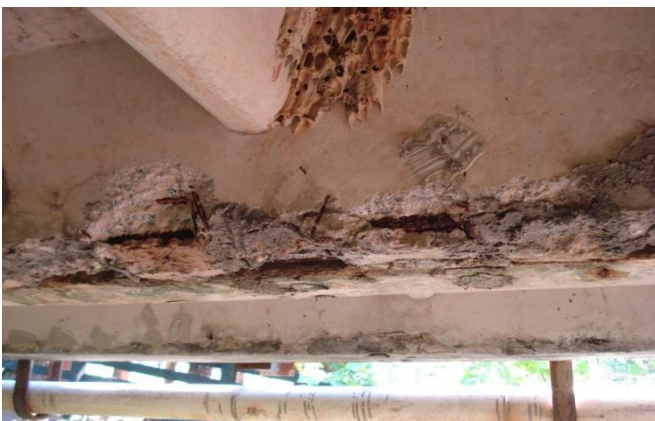
121-5009-0 – Main bars exposed due to spalling

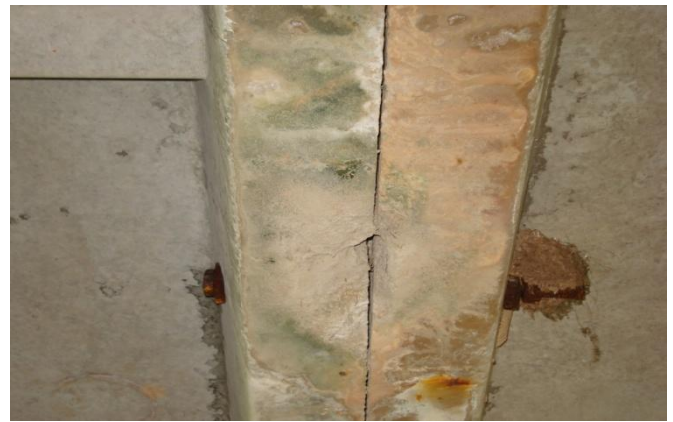
121-5013-0 – Spalling on edge of precast double tee

<p>Repair Recommendations:          The pile encasements at Bent 3 should be extended to a point 2 feet below the mud line. The cracks and spalls in all precast concrete superstructure panels should be sealed to protect the reinforcement steel from corrosion</p>	<p>Repair/Replacement Priority: Medium          Estimated Cost for Repairs: \$7,500</p>
--	---

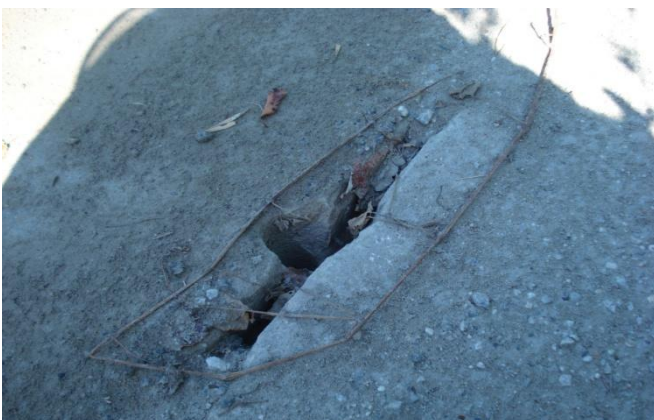
121-5013-0 – Drainage location with damage

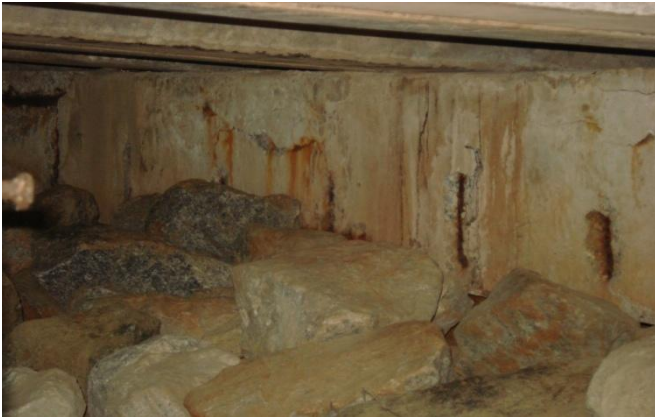
121-5014-0 Spalling on SE End Bent

Repair Recommendations:  
 The old timber pile cut-offs left in the stream channel should be removed to reduce the potential for drift accumulation. The spalling in the cap at the southern abutment should be sealed. Install advance signage for single lane bridge ahead.

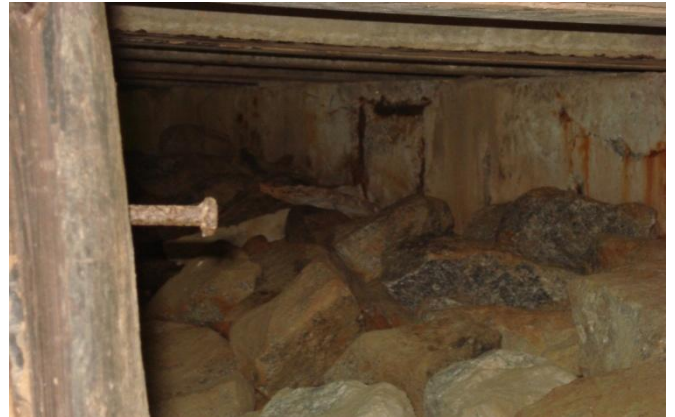
121-5014-0 Main rebar exposed due to spalling

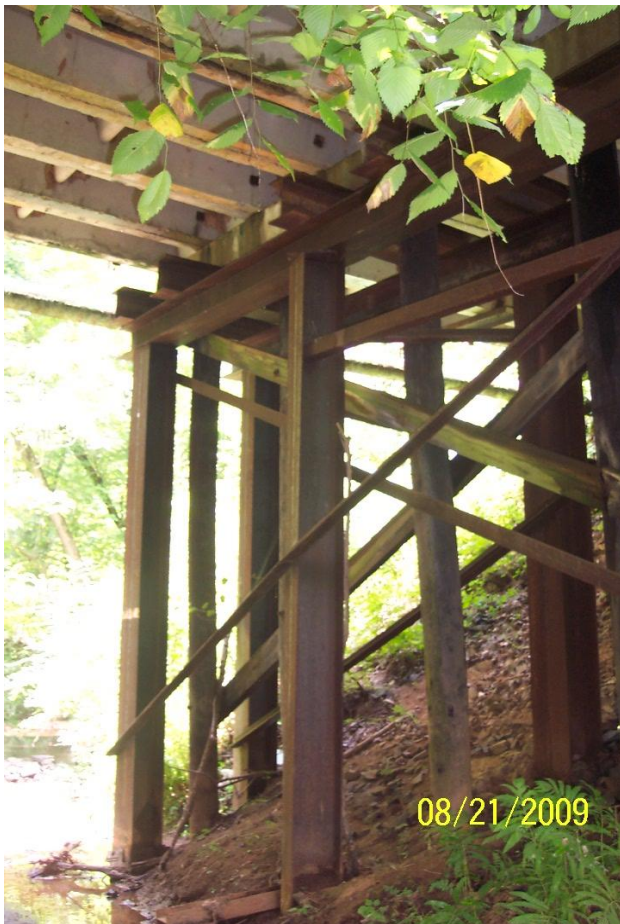
121-5015-0 – Twisted Steel H Pile

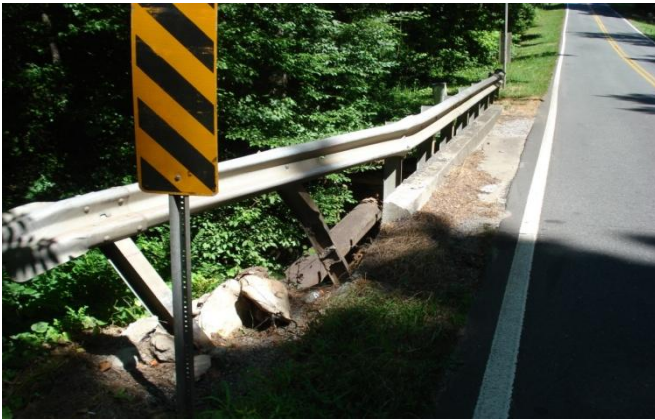
This bridge structure is in good condition with no reported serious structural defects. However, there is severe guardrail damage at the SW corner.

121-5202-0 – Damaged Guardrail on SW Corner

Repair Recommendations: Repair damaged guardrail immediately.	Repair/Replacement Priority: High Estimated Cost for Repairs: \$1,000
--	--

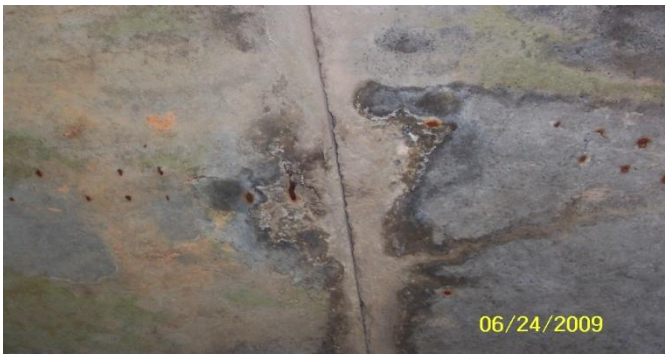
MLT01 – Spall location underside of beam

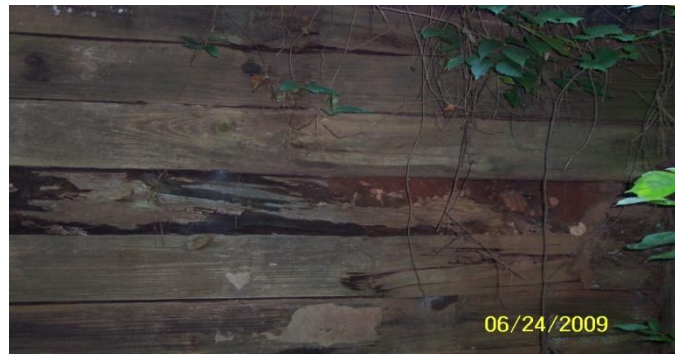
MLT01 – Timber wingwall damage Southeast Corner

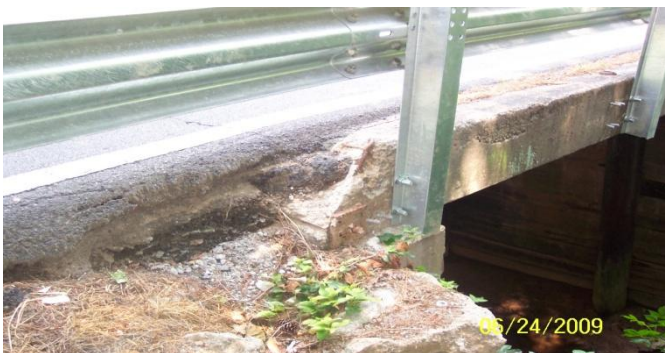
MLT01 – Concrete damage Southeast Corner

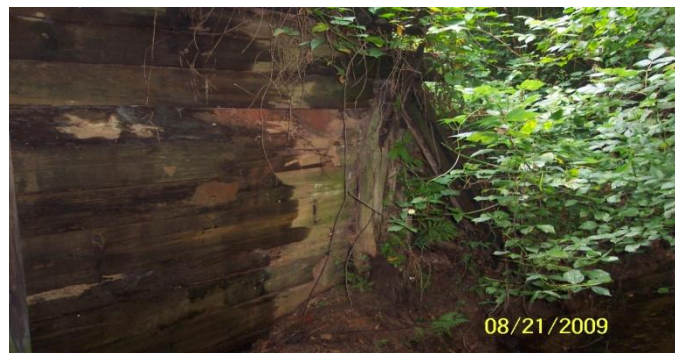
MLT01 – Timber Pile Damage Northwest Corner

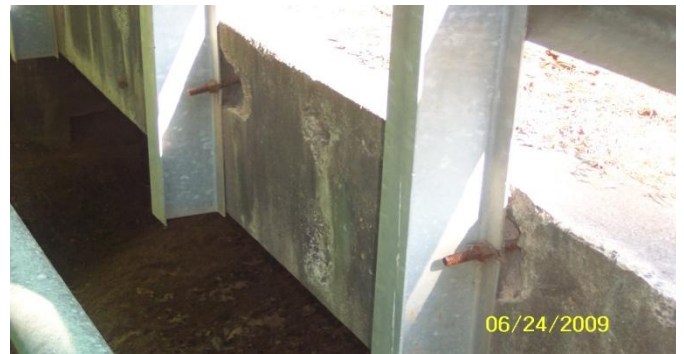
MLT04 – Guardrail anchor bolt spalling along Southside

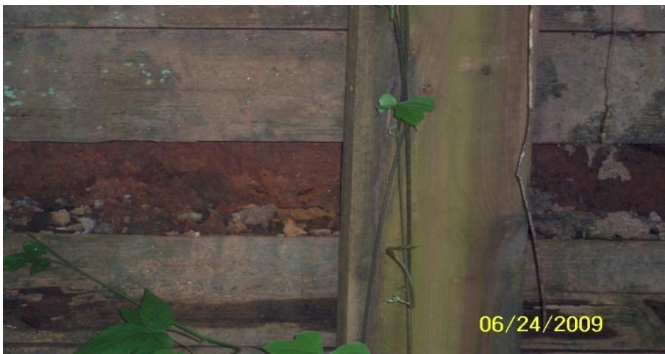
MLT05 – Timber wingwall damage Northeast Corner

**Repair Recommendations:**  
 Install W-beam guardrail to replace pipe railing. Patch and/or seal asphalt wearing surface on bridge deck. Level asphalt approach paving at each end. Closely monitor condition of timber piling & sheeting material at each end of bridge.

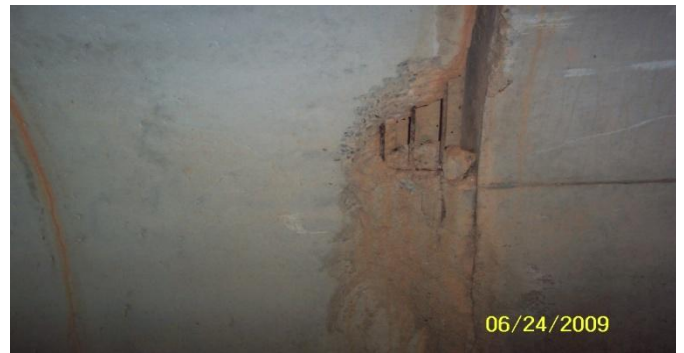
MLT06 – Spall location within pipe
