# Arnold Mill Rd (SR 140) Over Little River

Bridge ID 057-0029-0

**Road:** Arnold Mill Rd (SR 140)  
**Over:** Little River  
**Between:** Old Arnold Mill Rd  
 And Hickory Flat Hwy  
**Structure Type:** Simply Supported Steel Girder  
**Year Built:** 1952  
**Length:** 284 FT  
**Width:** 32.1 FT  
**Span:** 5 Spans  
**Deck:** Cast-in-place Concrete w/Asphalt W.S.  
**Superstructure:** 5 - Steel Girders  
**Substructure:** Concrete Cap and Column  
**Vehicle Protection:** Concrete Railing  
**Paint System:** Lead Chromate Oil Alkyd System  
**Posted Load Limits:** NO  
**Bus Route:** NO  
**Sufficiency Rating:** 39.45  
**Utilities:** Gas  
**Date of Inspection:** 6/2/2008

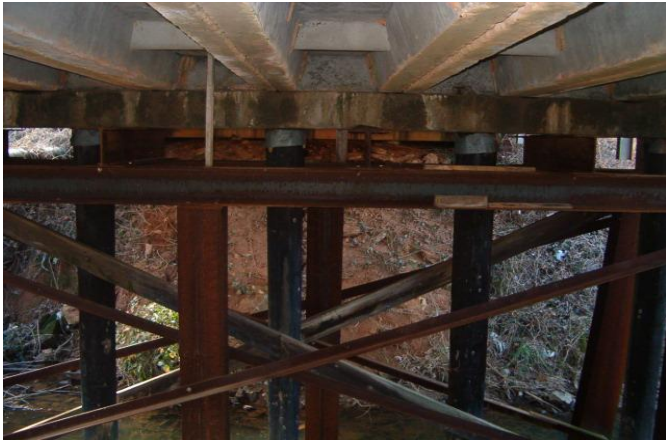
This structure is in poor condition with corrosion of the steel substructure components. Spalls on the bottom of the beams have exposed portions of the reinforcement steel.

121-0281-0 – Substructure repairs in place

**Repair Recommendations:**  
 The steel piles in the stream channel should be cleaned and painted. Furthermore, these piles should be protected with reinforced concrete encasements extending from points 2 feet below the mud line to a point 2 feet above normal water. Exposed reinforcement on beams should be cleaned and covered to protect it from corrosion. Asphalt W.S. should be patched and sealed. Remove dirt/vegetation from both gutterlines.

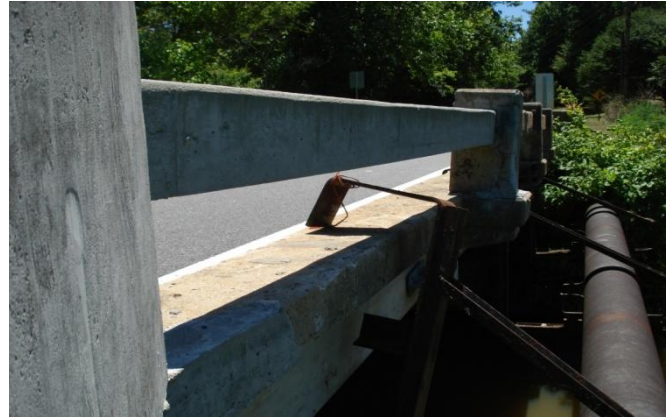
121-0283-0 – Water main attachment

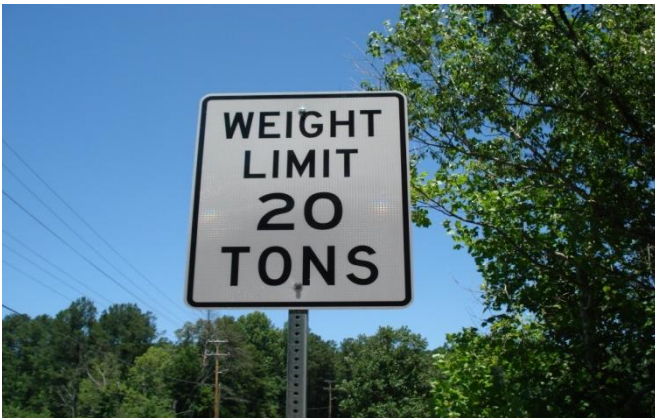
This structure is posted for 20 Tons H-Truck; 19 Tons Type 3 Truck and 28 Tons Timber Truck. This structure is posted due to overstress caused by the extra dead load of the 4.5 inch asphalt overlay. Upgrading the load carrying capacity to a point where posting is not required would require removal of this overlay. This bridge structure is in good condition but has corrosion of the steel superstructure. .

121-0283-0 – Posted Limit

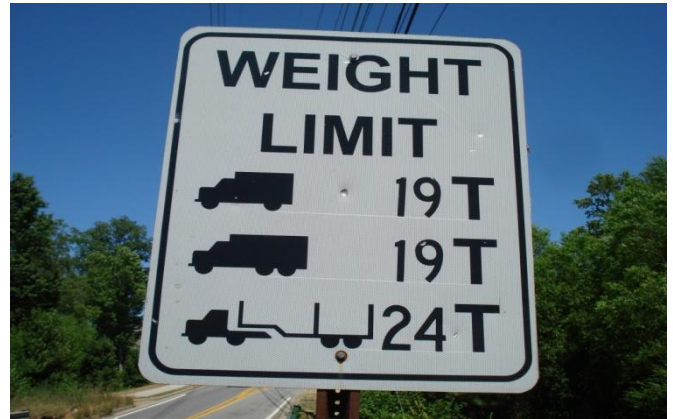
This bridge is located on the Fulton-Forsyth County line and is posted for 19 Tons H-Truck; 19 Tons Type 3 Truck and 24 Tons Timber Truck. This structure is posted due to overstress caused by the extra dead load of the 3.5 inch asphalt overlay. Upgrading the load carrying capacity to a point where posting is not required would require removal of this overlay. The bridge is in fair condition due to condition of beam panels, steel substructure piles and asphalt W.S. The eastern weight limit sign not present and approx. 15 feet of guardrail is missing due to accident on northeast corner.

121-0284-0 – Posted Limit

**Repair Recommendations:**  
 The steel piles throughout the structure should be cleaned and painted. The asphalt W.S. should be patched and sealed throughout. The spalled concrete/exposed reinforcing on beam panels should be cleaned and patched throughout. Vegetation growing in the vicinity of the structure should be cut and removed. Replace missing guardrail and weight limit posting sign at east end of bridge.

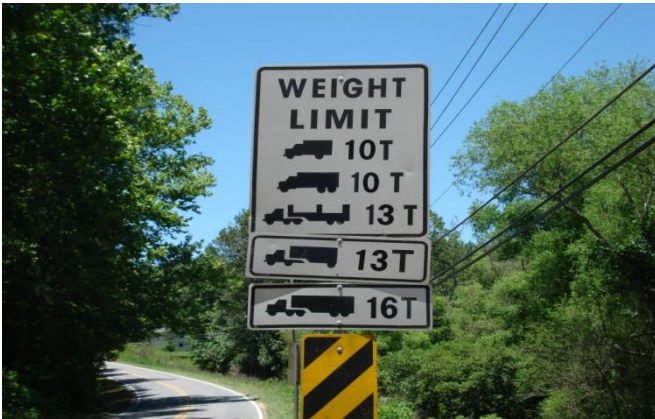
This structure is posted for 10 Tons H-Truck; 10 Tons Type 3 Truck; 13 Tons Timber Truck; 13 Tons HS Truck and 16 Tons Type 3S2 truck. This structure is posted due to the concrete deck slabs not being properly bolted together. This bridge structure is in satisfactory condition with corrosion of the steel substructure units. The pre-cast concrete superstructure panels have areas of spalls with exposed reinforced steel on the underside of the deck.

121-5003-0 – Posted Limit

**Repair Recommendations:**  
 The steel piles throughout the structures should be cleaned and painted. Furthermore, these piles should be protected with reinforced concrete encasements extending from points 2 feet below the mud line to a point 2 feet above normal water. The exposed reinforcement steel on the beams should be cleaned and sealed to protect it from corrosion. If the deck slab units are properly bolted together, then this structure could be significantly upgraded.

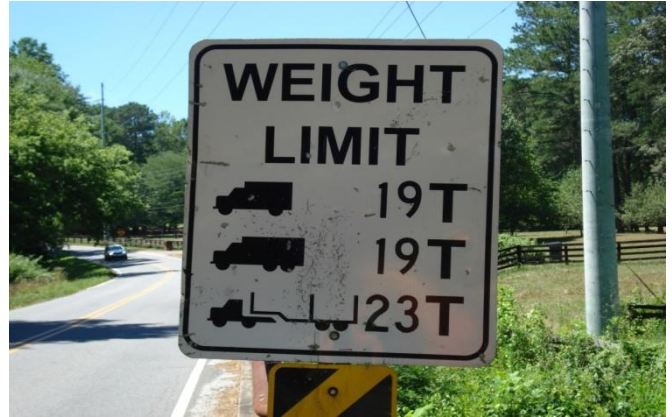
This structure is posted for 19 Tons H-Truck; 19 Tons Type 3 Truck and 23 Tons Timber Truck. This structure is posted due to overstress caused by the extra dead load of the 4 inch asphalt overlay. Any upgrade of the load carrying capacity would require removal of this overlay. This bridge structure is in satisfactory condition with no other reported deficiencies except isolated exposed and corroded rebar on underside.

121-5004-0 – Posted Limit

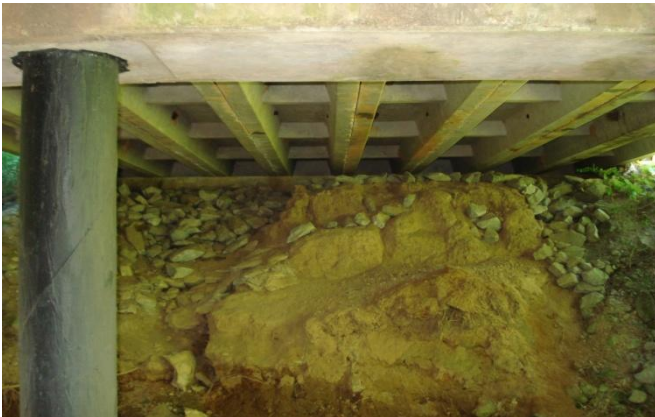
121-5004-0 – Underside Structure View

Repair Recommendations: Clean and cover exposed reinforcing steel on underside.	Repair/Replacement Priority: Low Estimated Cost for Repairs: \$2,500
--	---

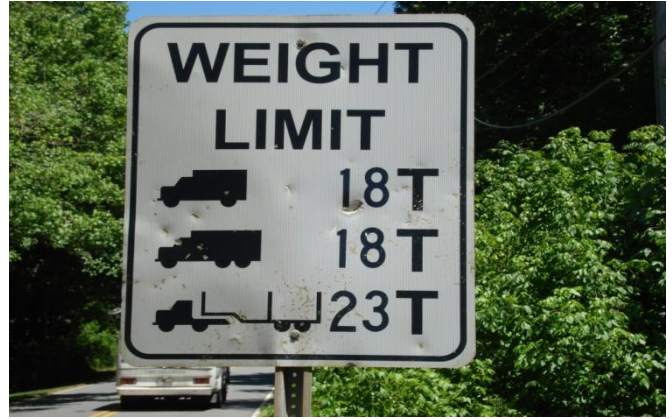
This structure is posted for 18 Tons H-Truck; 18 Tons Type 3 Truck and 23 Tons Timber Truck. This structure is posted due to overstress caused by the extra dead load of the 4 inch asphalt overlay. Any upgrade of the load carrying capacity would require removal of the asphalt overlay. This bridge structure is in satisfactory condition with the exception of the substructure which is in fair condition. The foundation piles beneath both abutments are exposed.

121-5005-0 – Posted Limit

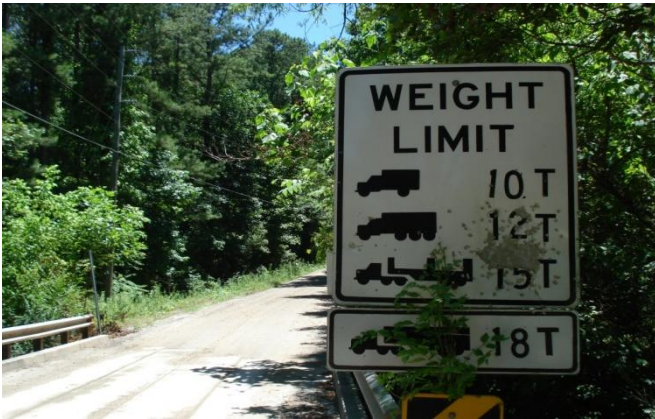
121-5007-0 – Posted Limit

\* load limit sign not required and may be removed per GDOT inspection. This single-lane bridge is in good condition with no serious reported structural defects.

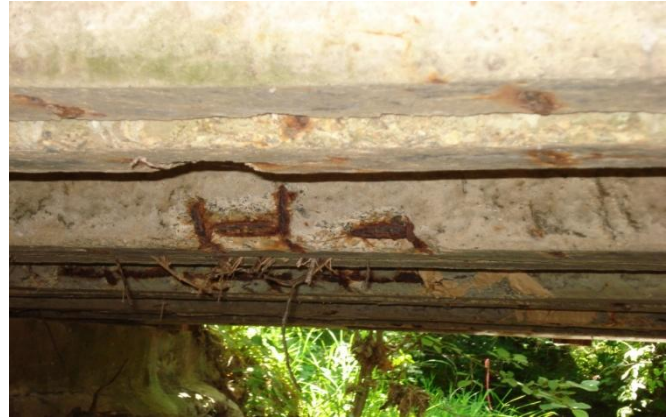
121-5008-0 – Underside Structure View

\* load limit sign not required and may be removed per GDOT inspection. This single-lane bridge structure is in fair condition. Minor cracking and spalls on the bottom of several superstructure panels have exposed the reinforcement steel.

Repair Recommendations:  
 Install advance signage for single lane bridge ahead.  
 The concrete spalls on the underside of the panels should be repaired to protect the reinforcement steel from corrosion.

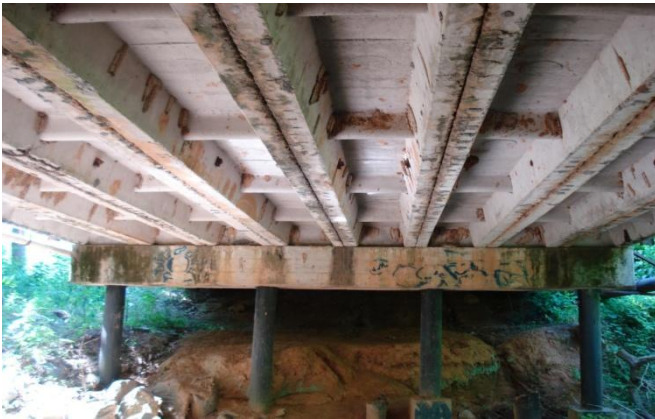
121-5009-0 – Underside Structure View

This structure is in satisfactory condition. There is moderate concrete spalling scattered throughout the precast beam members resulting in exposed and corroded reinforcing steel. Inadequate patching has failed in several locations. The asphalt wearing surface has significant cracking along bridge end joints and along beam joints.

Repair Recommendations:  
 Asphalt wearing surface needs to be patched and sealed. Spalling of precast beams needs to be patched, exposed reinforcement needs to be cleaned prior to patching concrete.

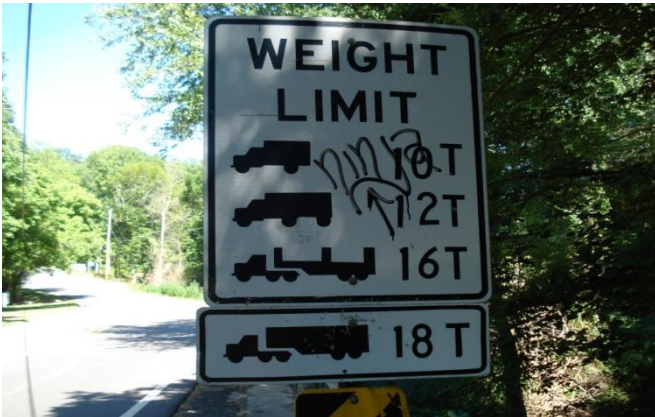
121-5010-0 – Posted Limit

\* load limit sign not required and may be removed per GDOT inspection. The bridge structure is in satisfactory condition with drift accumulated at bent #2.

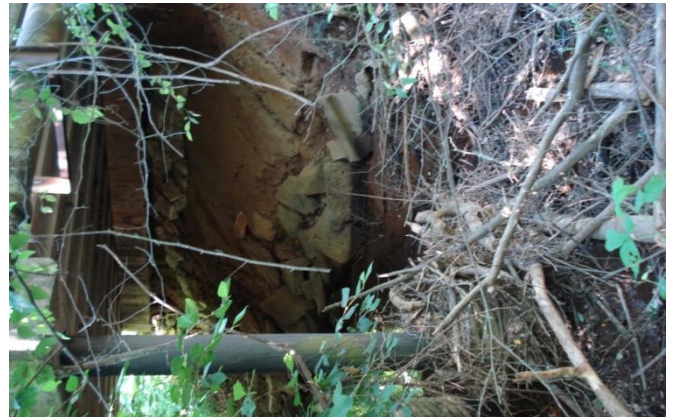
121-5010-0 – Substantial debris on creek channel

Repair Recommendations:  
 Drift accumulation at Bent 2 should be removed to reduce further accumulation and the possibility of scour.

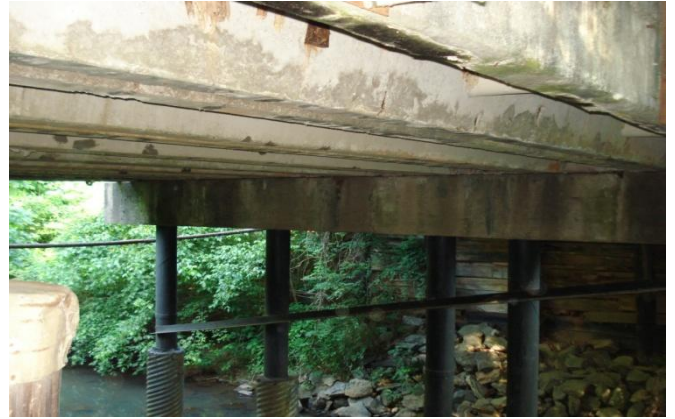
121-5011-0 – Underside Structure View

This bridge structure is in satisfactory condition with undermining of the concrete encasements at piles #1 and #3 at bent 2.

Repair Recommendations:  
 The concrete pile encasements at Bent 2 should be extended to a point 2 feet below the mud line.

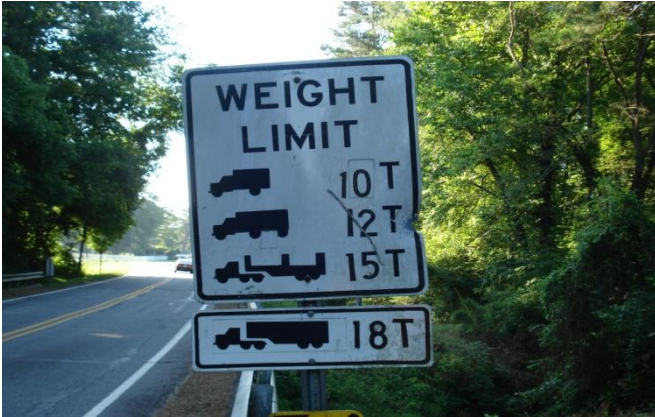
121-5012-0 – Posted Limit

\* load limit sign present on north end of bridge only but may be removed per GDOT inspection. This bridge structure is located on the Fulton-Cherokee County line and is in satisfactory condition with spalling of the concrete superstructure. Beam #1 in Span#1 is spalled rear of bent#2.

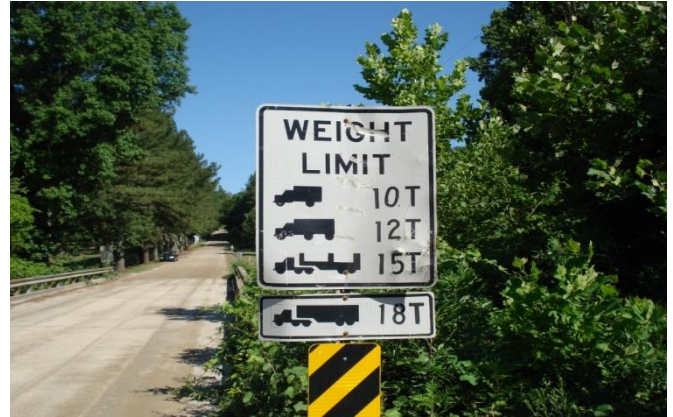
121-5013-0 – Posted Limit

\* load limit sign not required and may be removed per GDOT inspection. This bridge structure is in fair condition with undermining of the pile encasements at bent #3. .

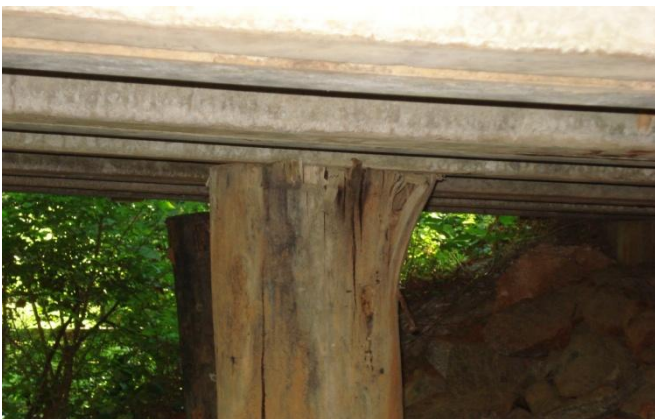
121-5014-0 Deck concrete panels bearing on pile

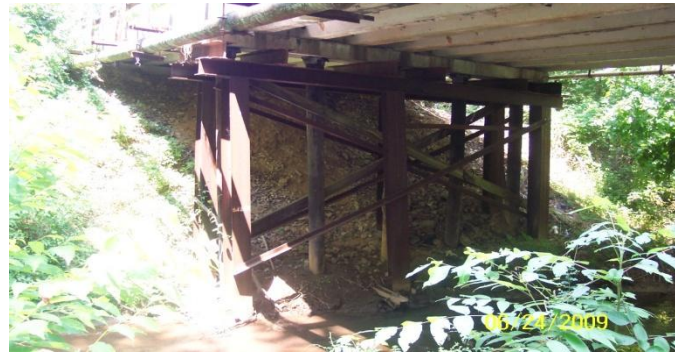
121-5015-0 – Elevation North View

This bridge structure has undergone a significant rehabilitation of the pile bents and has no reported deficiencies. Currently in fair condition (Sufficiency Rating 18.71 but needs to be verified with GDOT based on recent repairs)

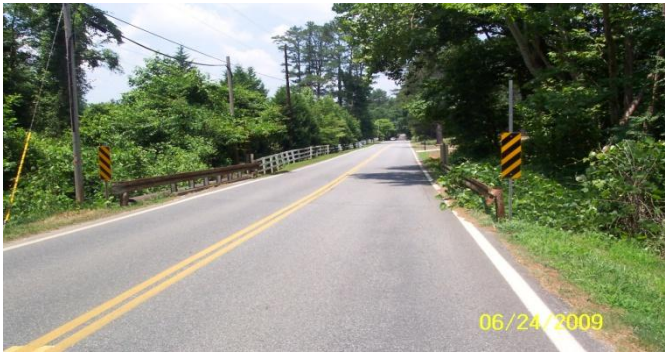
121-5016-0 – Roadway North View

Repair Recommendations:  
Secure guardrail anchorages at NE and SE corners of bridge.

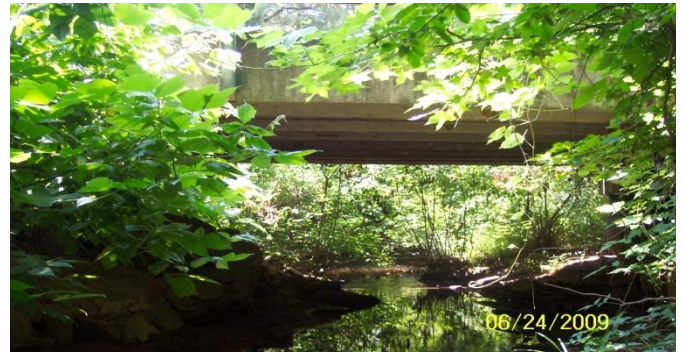
121-5016-0 – Elevation West View

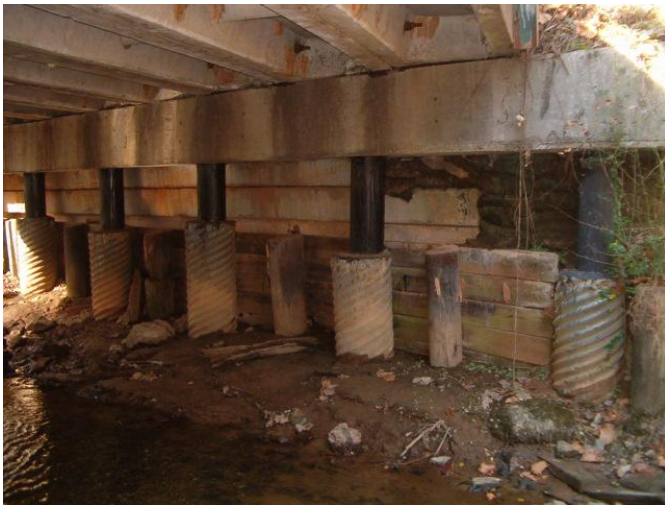
\* At time of inspection, the posting signs were missing. These signs are required and must be replaced. Post this structure for 16 Tons H-Truck; 17 Tons Type 3 Truck and 24 Tons Timber Truck. This structure requires posting due to the low original design capacity. A replacement structure is required to upgrade this structure to a point where posting is no longer required. This bridge structure is in fair condition with no reported deficiencies.

121-5016-0 – Substructure repairs in place

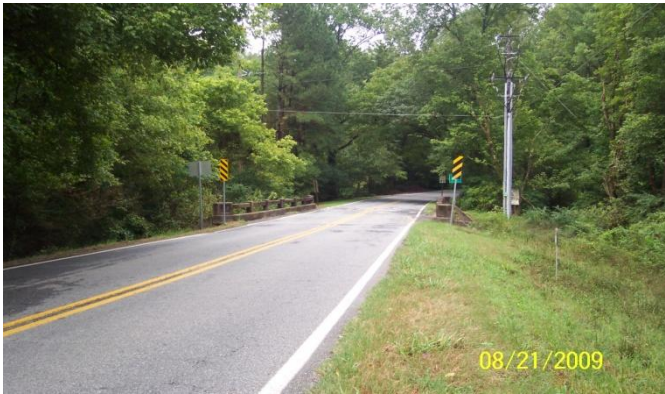
This all concrete bridge structure is located on the Fulton-Cherokee County line and is in fair condition with no reported deficiencies.

121-5106-0 – Roadway South View

Repair Recommendations:  
 Install approach guardrail at all four corners and anchor to bridge endposts.

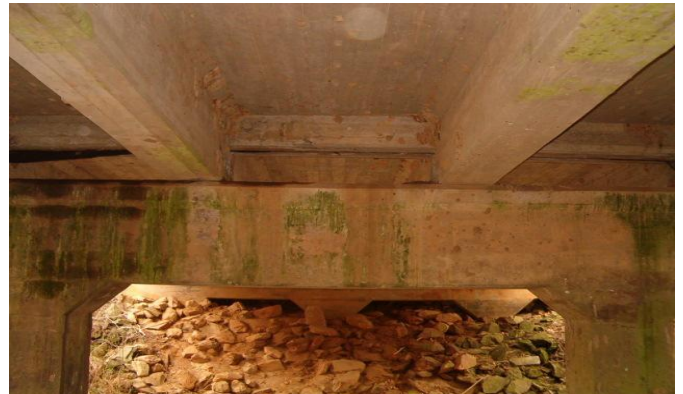
121-5106-0 – Underside Structure View

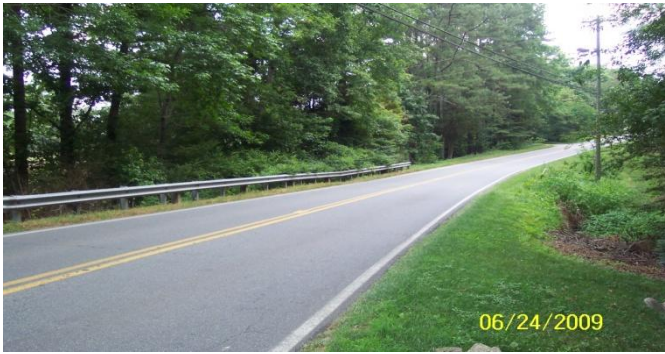
This arch culvert is in good condition with no reported deficiencies.

121-5107-0 – Roadway North View

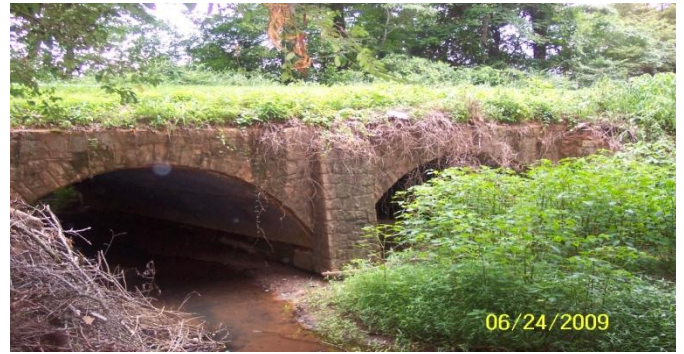
121-5107-0 – Elevation view

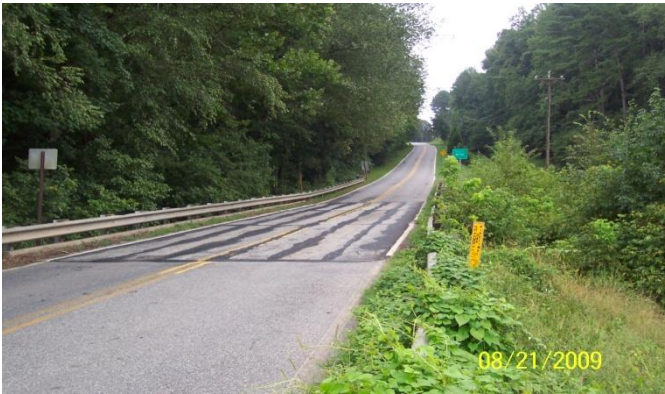
121-5151-0 – Roadway East View

**Repair Recommendations:**  
 Cracks in asphalt W.S. have been sealed; however, repair of eroded end slopes beneath bridge due to prior seepage of water thru deck panel joints is recommended. Clear dirt/debris and vegetation from both gutterlines.

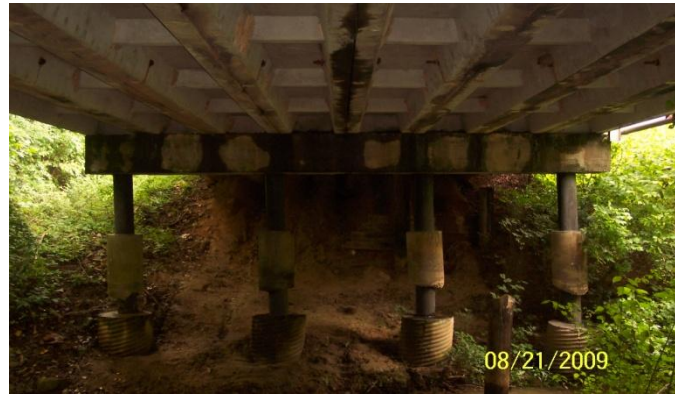
This structure is located on the Fulton-Cherokee County line and is posted for 10 Tons H-Truck; 12 Tons Type 3 Truck; 15 Tons Timber Truck and 18 Tons Type 3S2 Truck. This structure requires posting due to the concrete deck slab panels not being properly bolted together. If the panels were properly bolted and grouted together, this bridge could be upgraded to a point where posting would not be required. This bridge structure is in satisfactory condition with the exception of the substructure units. The concrete encasement at pile#2 of bent#2 has undermined.

121-5151-0 – Pile Encasement at Bent 2

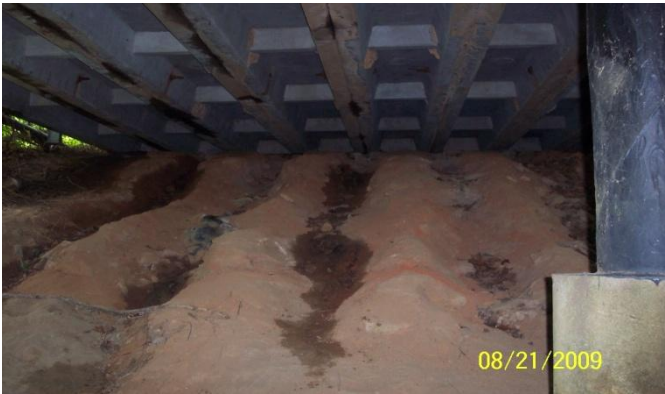
121-5151-0 – End Fill

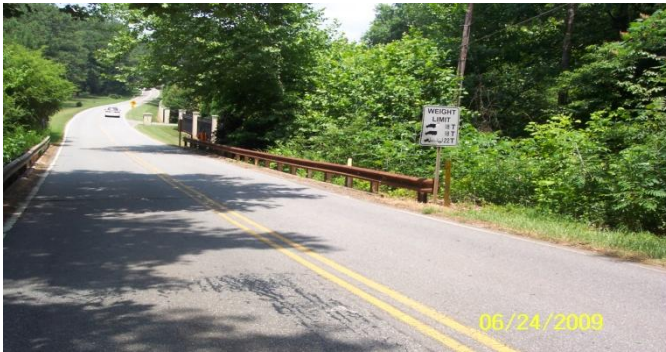
121-5153-0 – Roadway North View

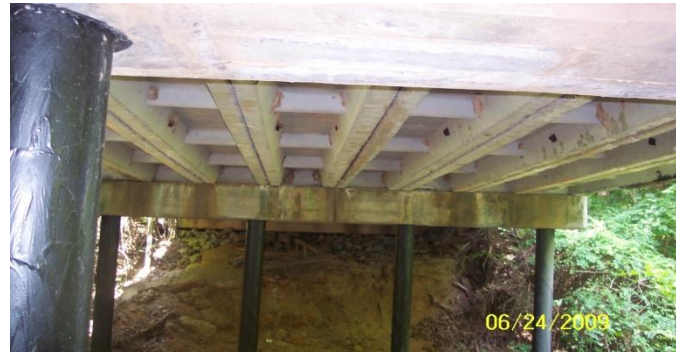
This structure is posted for 18 tons H-Truck; 18 Tons Type 3 Truck and 22 Tons Timber Truck. This structure is posted due to overstress caused by the extra dead load of the 4.5 inch asphalt overlay. Any upgrade of the load carrying capacity would require removal of this overlay. At the present time, no maintenance repairs are required to maintain this structure at the current rating.

121-5153-0 – Bridge Superstructure

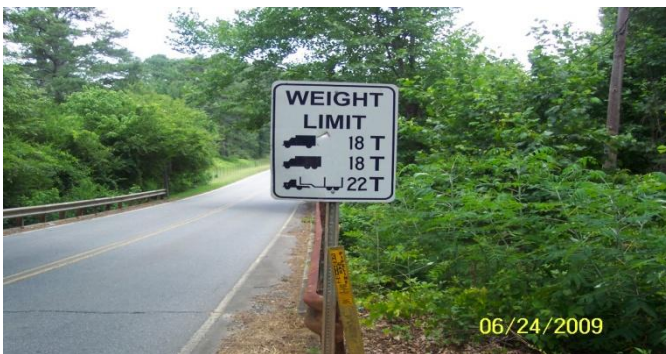
121-5153-0 – Posted limit

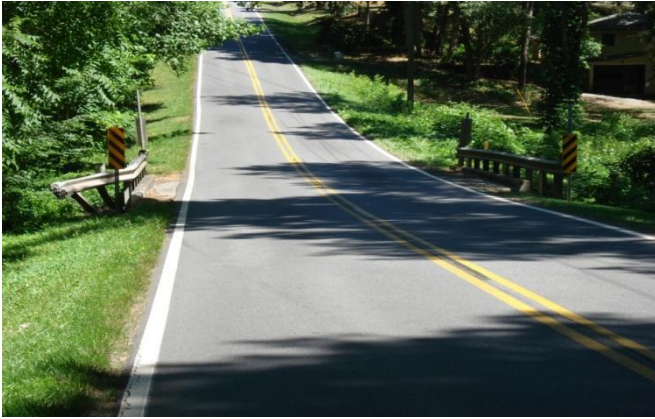
121-5202-0 – Roadway North View

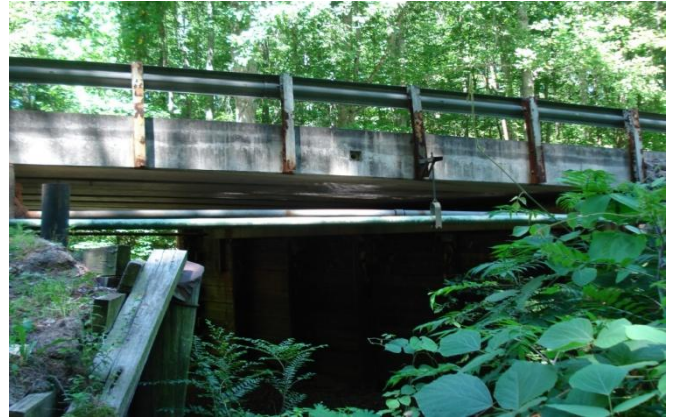
This bridge structure is in good condition with no reported serious structural defects. However, there is severe guardrail damage at the SW corner.

121-5202-0 – Elevation West View

Repair Recommendations: Repair damaged guardrail immediately.	Repair/Replacement Priority: High Estimated Cost for Repairs: \$1,000
--	--

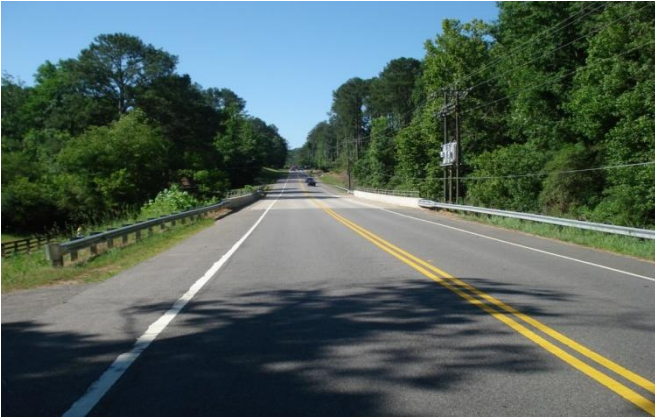
121-5303-0 – Roadway South View

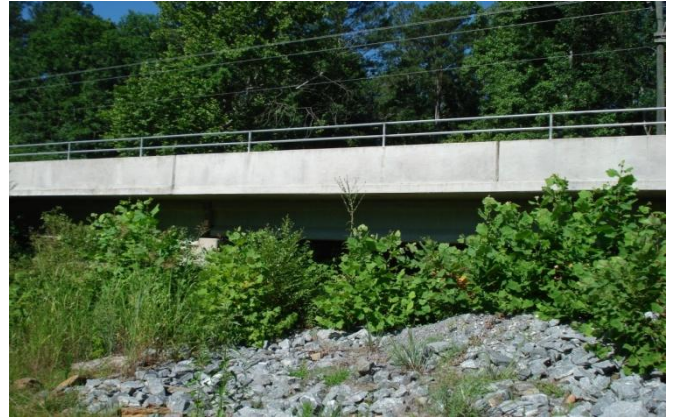
121-5303-0 – Elevation West View

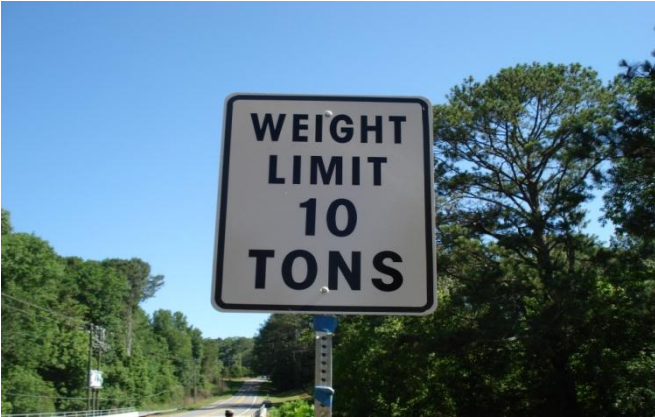
\* The load limit sign is no longer required and may be removed per GDOT inspection. This is a new structure constructed in 2004; however, the inventory data is not available on GDOT's website.

121-5303-0 – Posted Limit (not req'd.)

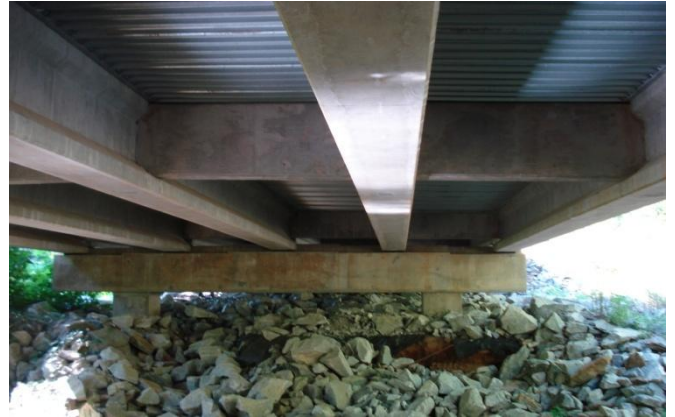
121-5303-0 – Underside structure View

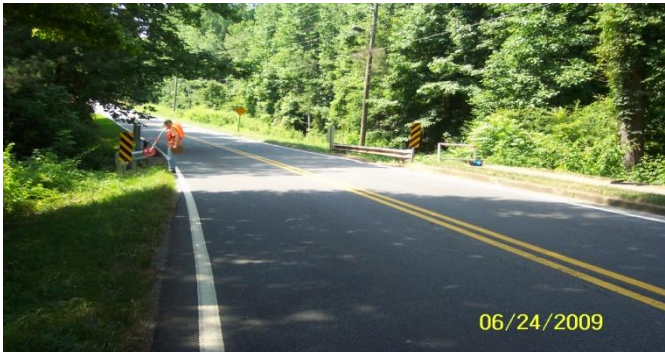
Structure consists of precast concrete flat slab panels with asphalt overlay. The bridge is located on a heavily traveled road and is in fair condition. Deck drain openings have been paved over with asphalt. Minor spalls observed along underside of bridge and at curb in SE corner. Guardrail posts missing along west side of bridge making guardrail inadequate for vehicle protection. The timber wingwalls are in fair to poor condition. Three of the four wingwall corner posts have severe rot/decay just above mudline. Both wingwalls on east (upstream) side of bridge have rotated slightly and earth fills have eroded due to inadequate stormwater drainage from road. Some of the timber lagging members have failed due to rot.

MLT01 – Roadway South View

<p><b>Repair Recommendations:</b>          For safety reasons, this bridge should be replaced with a wider structure on improved alignment to safely accommodate heavy traffic volumes and turning movements at adjacent school entrances. Provide adequate shoulders and sidewalk on east side.</p>	<p><b>Repair/Replacement Priority:</b> High  <b>Estimated Cost for Repairs:</b> \$850,000</p>
--	---

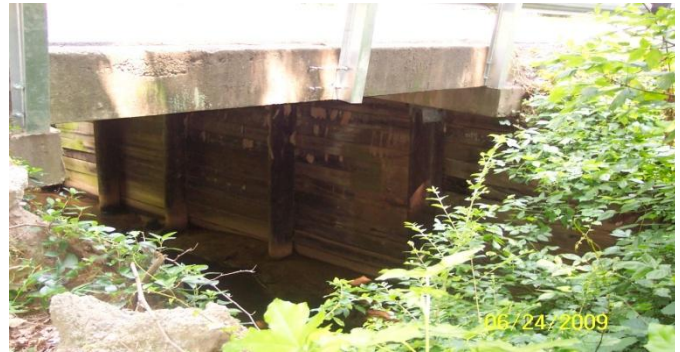
MLT01 – Elevation View

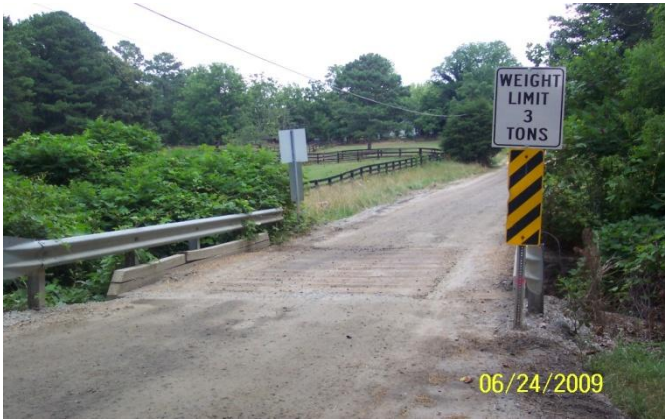
This single lane bridge is posted for a weight limit of 3 Tons. Both approach roadways are gravel and exhibit moderate settlement with several deep depressions in the roadway. Both bridge seats have debris build-up, which indicates failure of the endwalls. The timber deck planks are in good condition. The bridge rail is composed of steel W-beam guardrail nailed to the timber curb which is substandard and loose at several locations. The steel beams have severe rust, exfoliation and section loss. Even though the corrosion levels are severe, there are no signs of excessive deflection, rotation or failure in the steel members. No major defects were identified in the masonry walls, although the east abutment foundation has been undermined by the creek at the south corner.

MLT02 – Roadway East View

Repair Recommendations: Replacement with a prefabricated arch structure	Repair/Replacement Priority: High Estimated Cost for Repairs: \$250,000
--	--

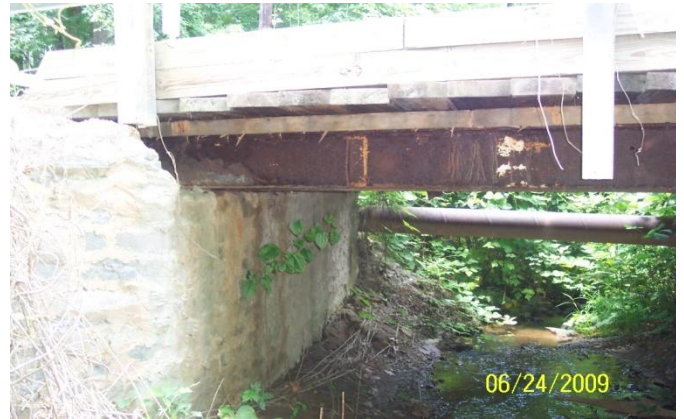
MLT02 – Elevation North View

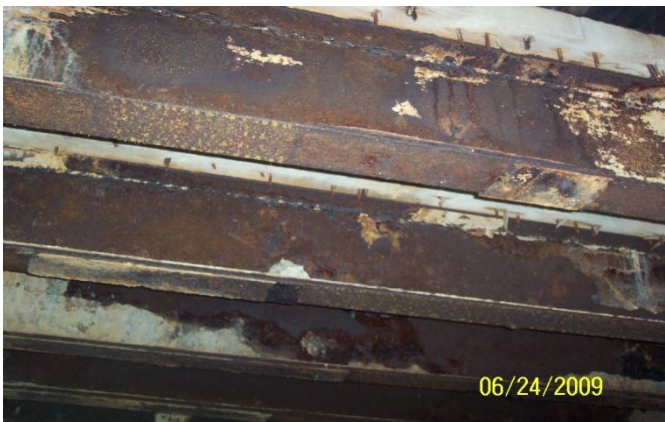
MLT02 – Superstructure from Below

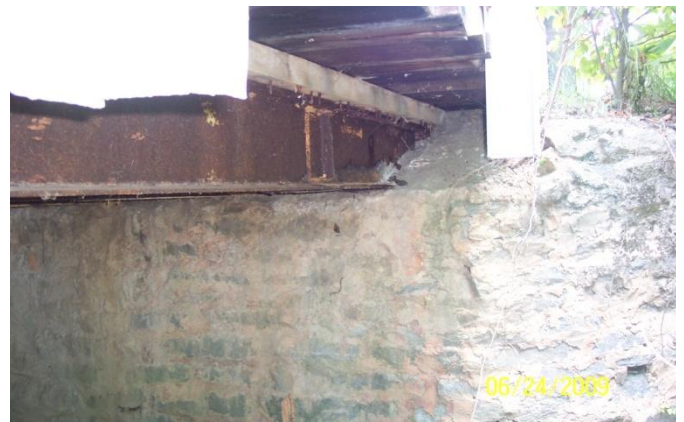
MLT02 – North Abutment

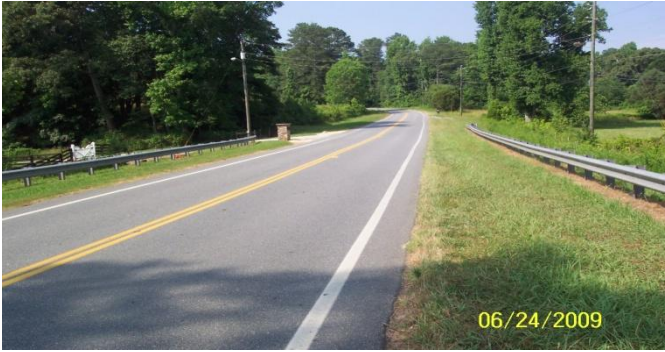
Structure consists of a skewed triple cell 8 ft x 8ft concrete box culvert. Structure is in good condition with only siltation of northern most cell observed.

MLT03 – Roadway Southwest View

Repair Recommendations:  
 Remove built up siltation from northern cell. Clear accumulated debris from south cells.

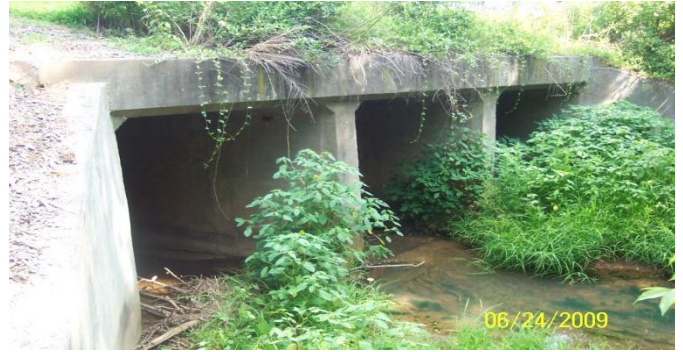
MLT03 – Elevation Southeast View

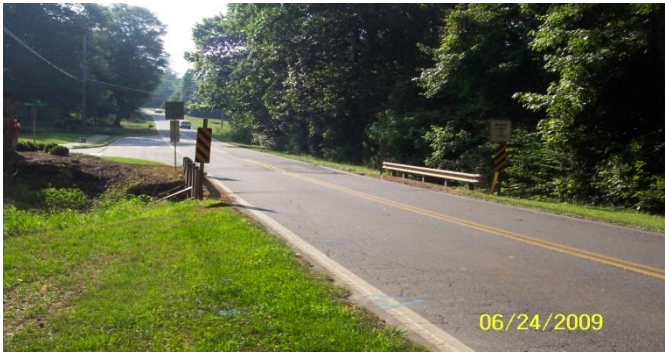
Structure consists of precast concrete double tee panels with asphalt overlay. Deck drain openings have been paved over with asphalt, water seepage thru cracks in wearing surface and down in between panels. Substructure consists of timber piles on a concrete cap. Timber planks are used to retain earth fill at end bents. The bridge is in fair condition. Deflection cracks observed in pavement at both ends of bridge and approach pavement has settled. It appears that the concrete stems have been patched but the patch material has begun peeling off in spots. Anchor bolts supporting guardrail posts have spalled along south side of bridge. Timber sheeting at SE corner has failed, and the SW corner post has failed due to rot. SW wingwall is beginning to fail at mudline.

MLT04 – Roadway West View

**Repair Recommendations:**  
 Patch and/or seal asphalt wearing surface on bridge deck. Level asphalt approach paving at each end. Closely monitor condition of timber piling & sheeting at ends of bridge and repair as needed.

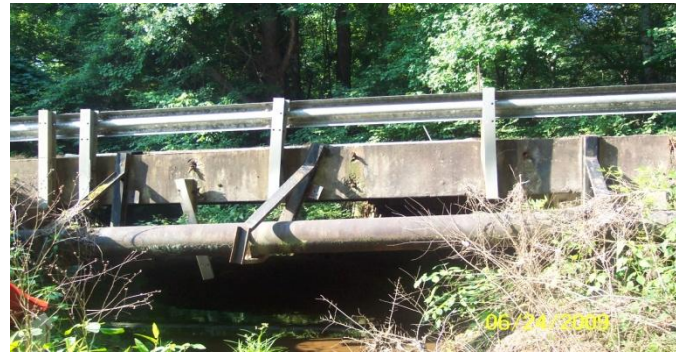
MLT04 – Elevation South View

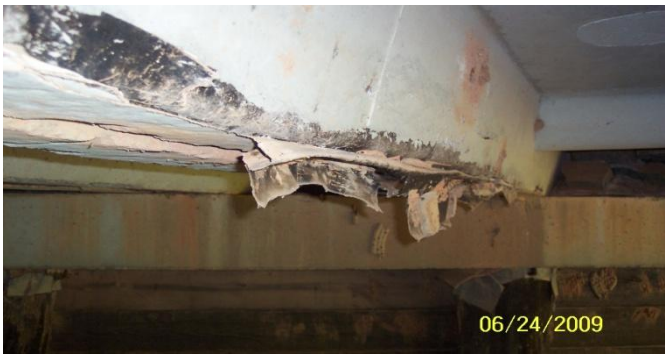
MLT04 – Fabric on underside of beam

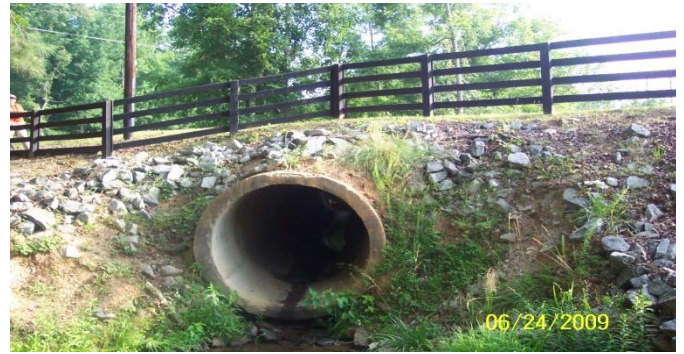
This pipe structure is in satisfactory condition with isolated spalls on interior. Three of the pipe segments at the outfall end have settled and separated, causing water to flow down through the joint between the segments and underneath the final pipe segment resulting in undermining. Minor spalling observed on exterior of pipe at outfall. Channel erosion and undermining of pipe observed at outfall.

MLT06 – Outfall Elevation View

**Repair Recommendations:**  
 Pump grout material in eroded areas at outfall end of pipe and beneath pipe to eliminate voids. Once voids are filled, seal gaps between pipe segments to prevent further undermining, erosion and pipe settlement.  
 Monitor roadway surface above pipe and outfall end of pipe to verify performance of repair.

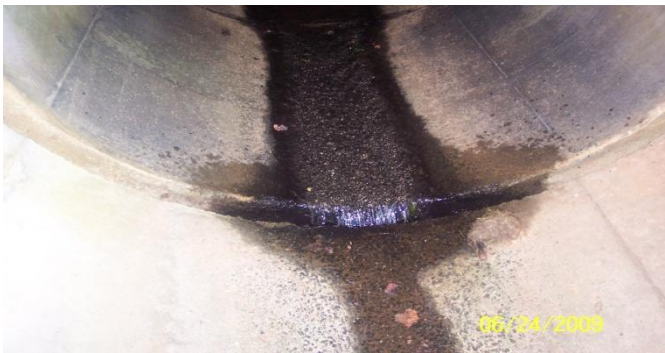
MLT06 – Last pipe segment at pipe outfall
